# Wildfire Guard Rehabilitation

## A Report for Critical Works

Prepared For  
Ministry of Forest,  
Burns Lake, BC

Prepared By  
Ken Nielsen, RPR

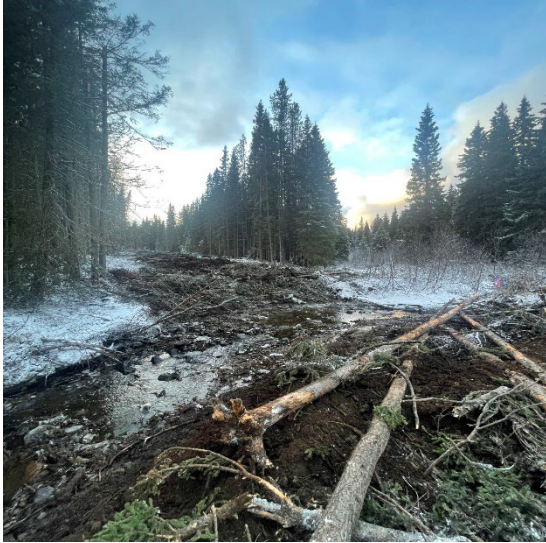
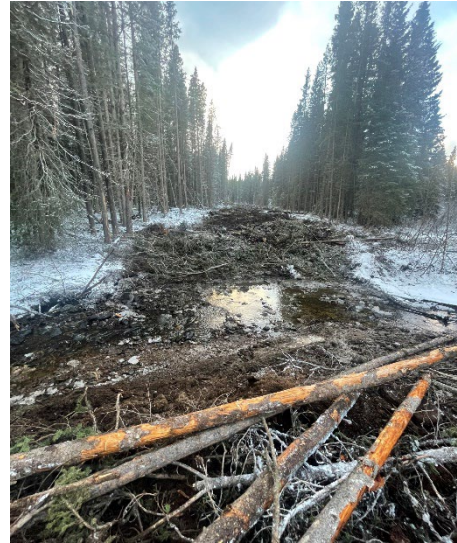
*Figure 1: Pictures of MG36-06*

*SITE 2: MG36 – 06*

This crossing is located on the guard MG36 starting at 11 km on the Haney FSR and ends at COOP Lake.

- Decks were removed from downstream of fire guard.
- All debris from salvage of decks was removed from down stream of guard.
- Cross drainage was constructed either side of stream crossing in the riparian.
- Full pull back of organics back onto guard either side of stream crossing.
- LWD placed on either side of stream crossing.

- *SITE 2: MG36 – 06, be sure water is flowing unobstructed and sediment/erosion control structures appear to be still working. Resourcing local willows from the area to be cut at an angle for plugs to be placed along the stream bank and followed up with more grass seeding.*

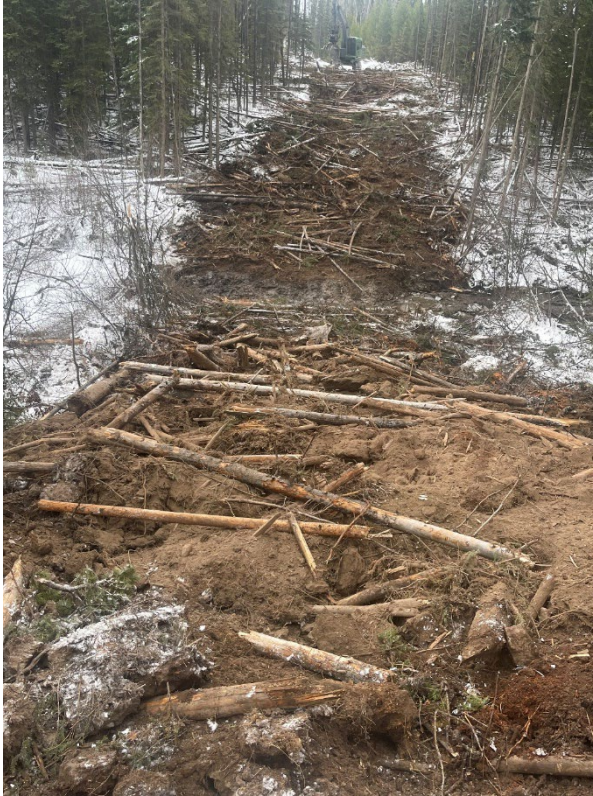
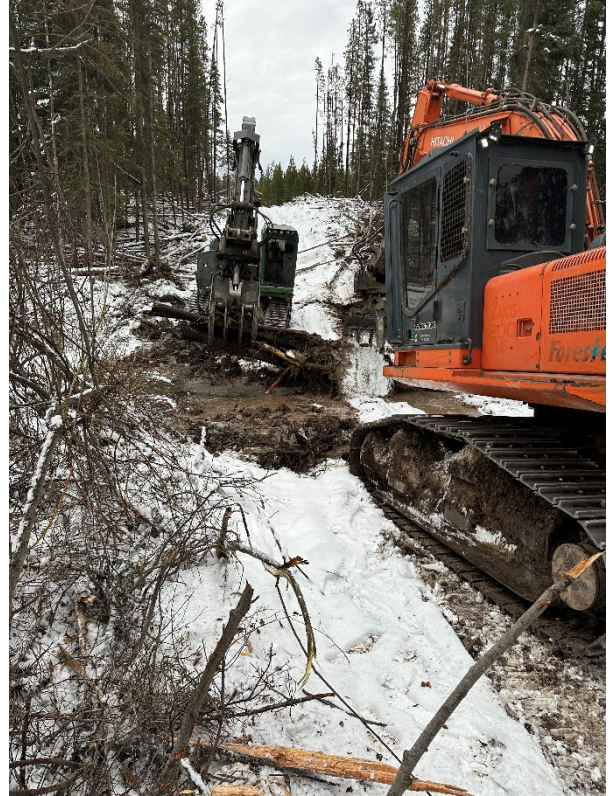
Figure 3: Picture of MG076-02

*SITE 3: MG076-02*

This crossing is located on the guard that starts at 2.5 km on the Augier FSR and runs parallel to highway 16 eastwards.

- All debris from salvage of decks was removed from down stream of guard.
- Cross drainage was constructed either side of stream crossing in the riparian.
- Full pull back of organics back onto guard either side of stream crossing.
- LWD placed on either side of stream crossing.

- *SITE 3: MG076-02, be sure water is flowing unobstructed and sediment/erosion control structures appear to be still working. Resourcing local willows from the area to be cut at an angle for plugs to be placed along the stream bank and followed up with more grass seeding.*

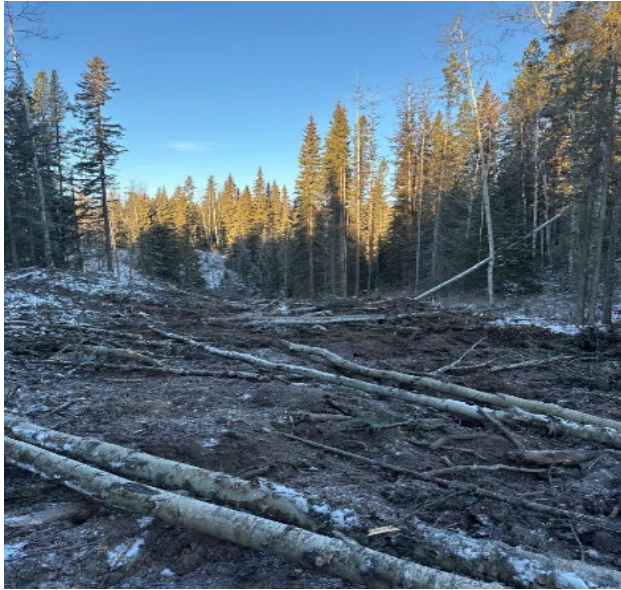
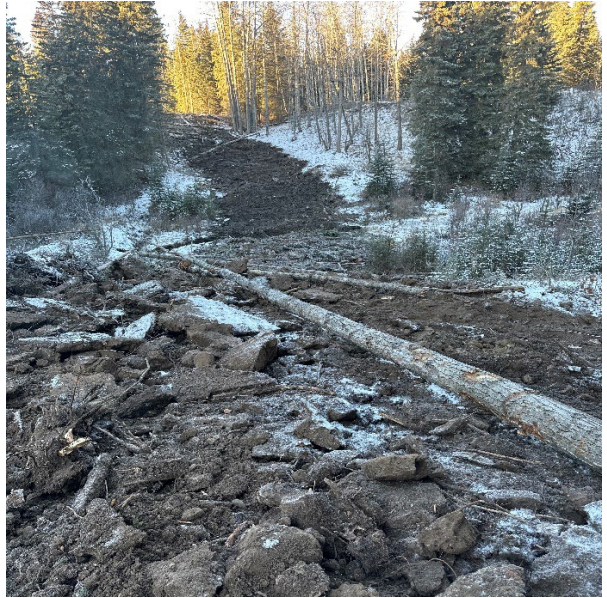
Figure 4: Pictures of MG082-02

*SITE 4: MG082-02*

This crossing is located on the guard that starts at 2.5 km on the Augier FSR and runs parallel to highway 16 eastwards almost to the end of guard. This is where some locals got a skidder stuck over the bank.

- All debris from salvage of decks was removed from down stream of guard.
- Cross drainage was constructed either side of stream crossing in the riparian.
- Full pull back of organics back onto guard either side of stream crossing.
- LWD placed on either side of stream crossing.

- *SITE 4: MG082-02, be sure water is flowing unobstructed and sediment/erosion control structures appear to be still working. Resourcing local willows from the area to be cut at an angle for plugs to be placed along the stream bank and followed up with more grass seeding.*

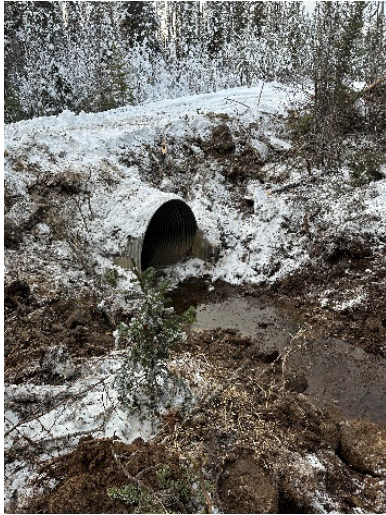
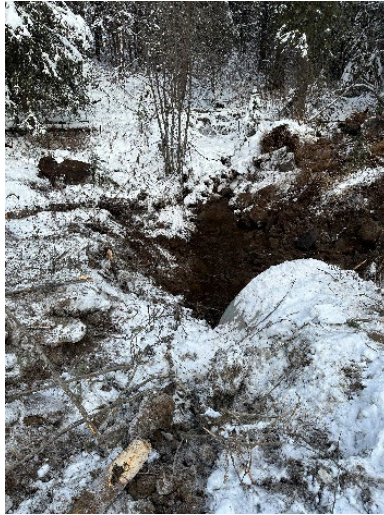
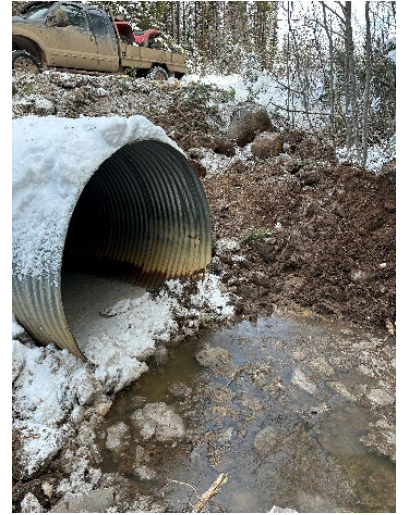
Figure 6: Pictures of REM005-17

*This site is located on the Gullwing Road, the ends of the culvert were filled in with dirt from wildfire suppression efforts.*

- All debris was removed from both ends of the culvert.
- Grass seed was applied.

- *SITE 5: REM005-17, be sure water is flowing unobstructed and sediment/erosion control structures appear to be still working. Follow up with more grass seeding.*

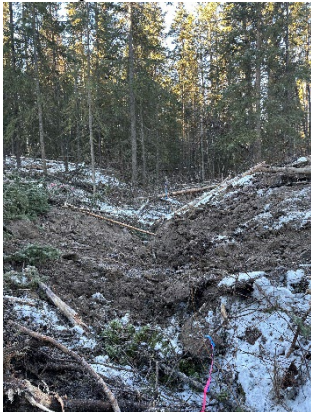
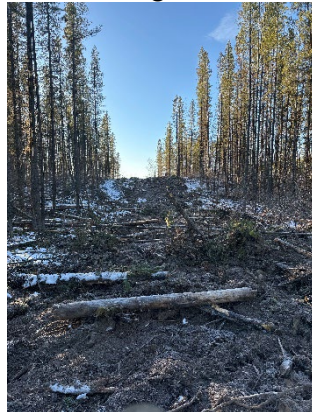
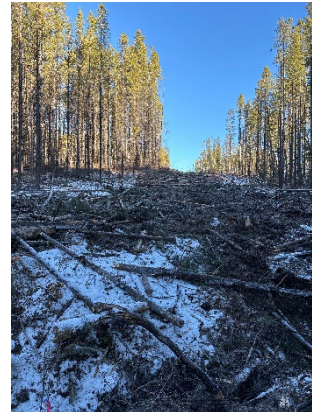
Figure 7: Pictures of MG128-01

*This site is located on the guard east of coop lake and runs north. This stream crossing is spring run off only, and there was no water at time of rehab.*

- All debris from salvage of decks was removed from down stream of guard.
- Cross drainage was constructed either side of stream crossing in the riparian.
- Full pull back of organics back onto guard either side of stream crossing.
- LWD placed on either side of stream crossing.

- *SITE 6: MG128-01, be sure water is flowing unobstructed and sediment/erosion control structures appear to be still working. Resourcing local willows from the area to be cut at an angle for plugs to be placed along the stream bank and followed up with more grass seeding.*

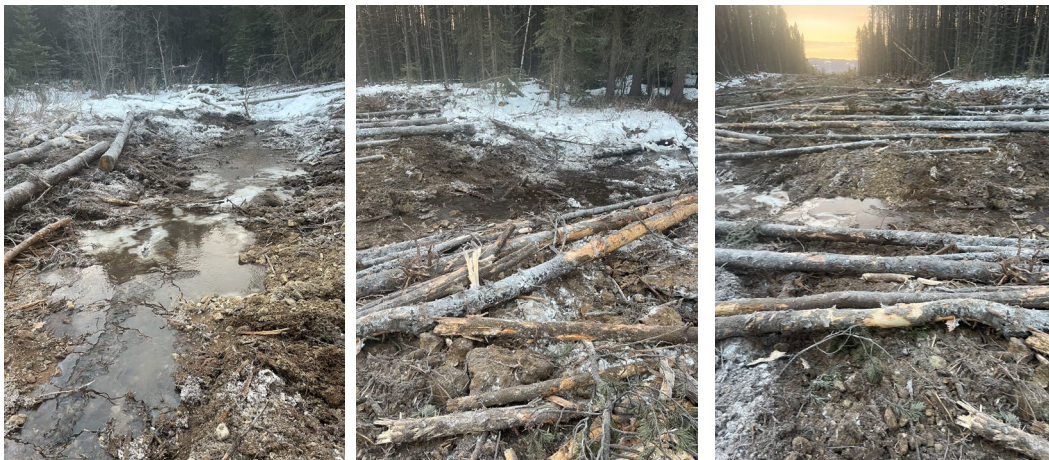
Figure 8: Pictures of MG034-06

*This site is located north of the Haney FSR and south of the Gullwing FSR. This is a non fish bearing stream but rehabbed under critical works to address spring run off issue's.*

- Cross drainage was constructed either side of stream crossing in the riparian.
- Full pull back of organics back onto guard either side of stream crossing.
- LWD placed on either side of stream crossing.

- *SITE 7: MG034 – 06, be sure water is flowing unobstructed and sediment/erosion control structures appear to be still working. Resourcing local willows from the area to be cut at an angle for plugs to be placed along the stream bank and followed up with more grass seeding.*
